Revamp of Phosgene Absorber

Petrochemical industry, India

- Petrochemical industry phosgene absorber revamp

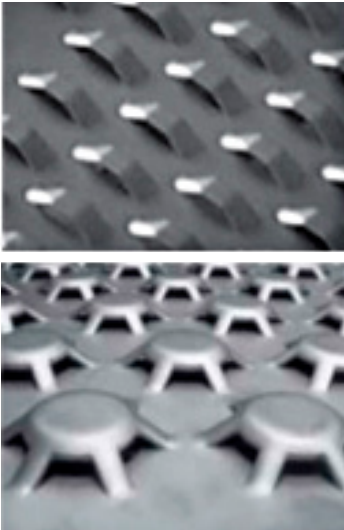
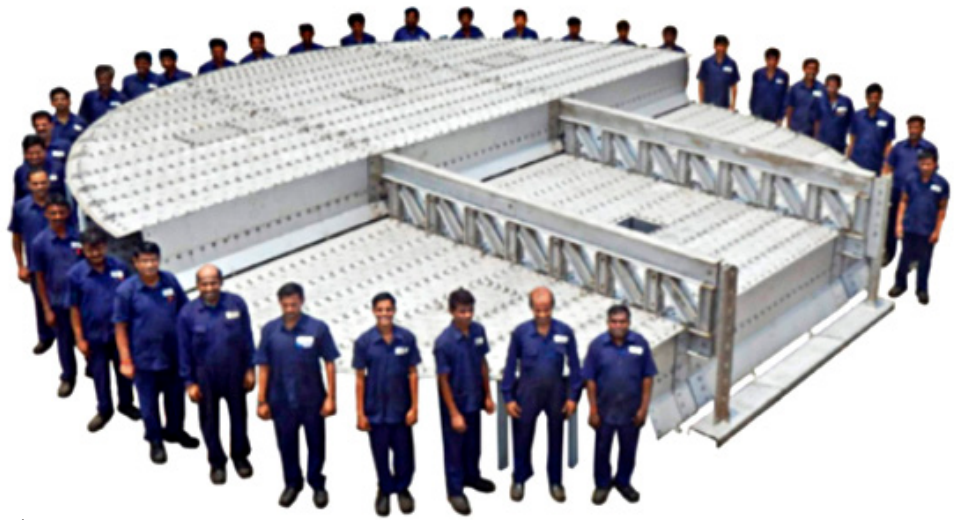
Valve Trays.

Since the column was not performing to peak capacity with very high pressure drops and bottom temperatures, the column was opened and inspected, and the trays were found to be very corroded.

Munters specialists performed a study and analysis. During the hydraulic rating of the existing valve trays, it was noted that the jet flood and pressure drop were quite high, which made the problem worse.

When studying the hydraulics of the existing trays, Munters specialists discovered that they were running at 130% jet flood, a very high-pressure drop. This caused the temperature at the bottom to be very high, which led to corrosion. Munters' specialists decided to replace these trays with high-capacity valve trays.

After studying and analyzing the problems, Munters recommended replacement of valve trays with high-capacity valve trays. High-capacity valve provide maximum open area and thereby reduce pressure drop.

Also, these trays could efficiently handle fouling services. Accordingly, thirty high-capacity valve trays were designed to suit the existing tray attachments, and they were manufactured and installed within 48 hours.
