Preventing cold storage condensation

Claus Sørensen A/S, Denmark

Case study:

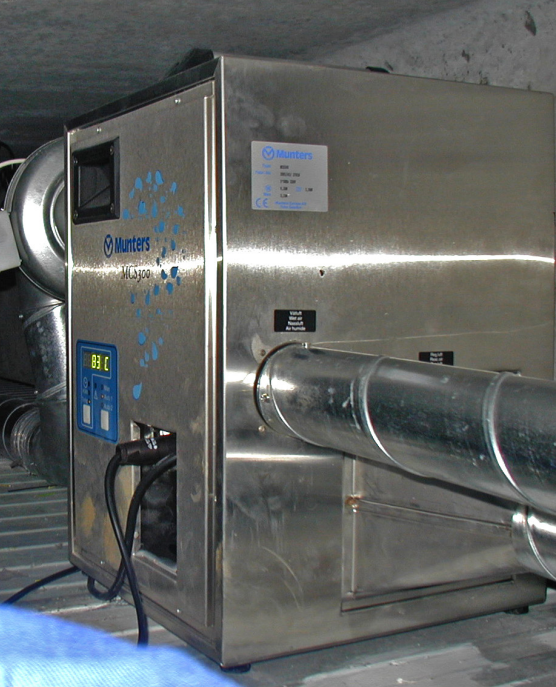
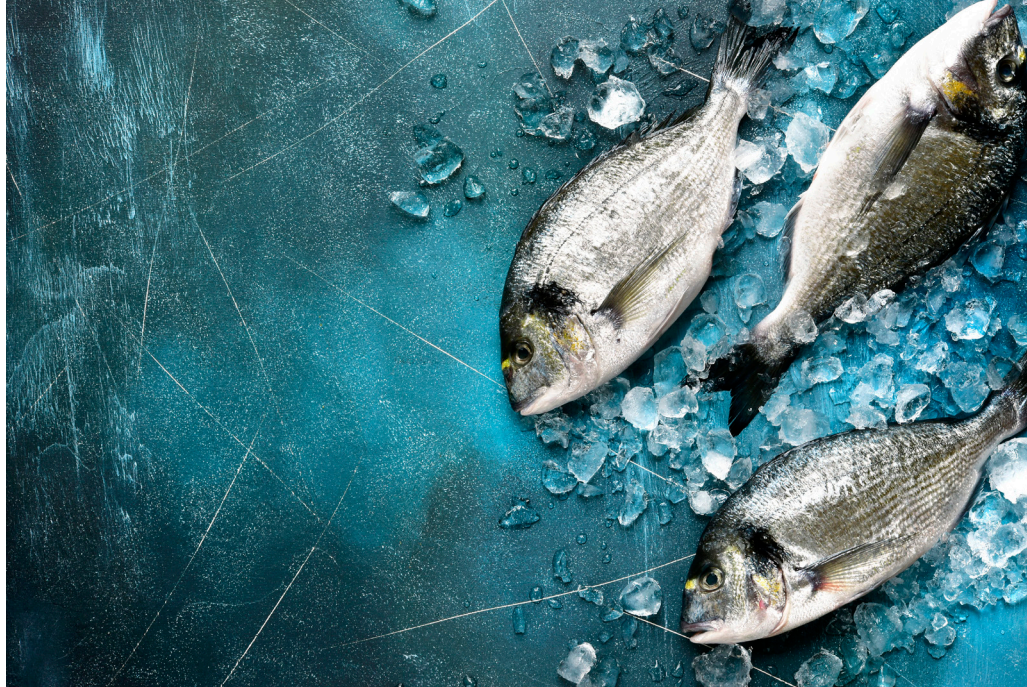
On top of the refrigerated room, condensation appears as water or ice that can completely cover the ceiling area and cause significant damage. In addition to damage to the building, ice and frost can form on the uninsulated parts of the refrigeration system such as vents and automated parts.

After an inspection of the facility, Munters developed a solution proposal that the company immediately chose to implement. Two small dehumidifiers were installed on the ceiling, and these now ensure a stable, low humidity that prevents the formation of condensation.
